NASA  
Spaceport Engineering and Technology Directorate  
Labs Division  
Kennedy Space Center, Florida

KSC-MSL-0597-2002

SUBJECT: Failure Analysis of Wheel Studs (P/N 9-049-104995) from an RT 990 60 Ton Crash Crane (S/N 75190)

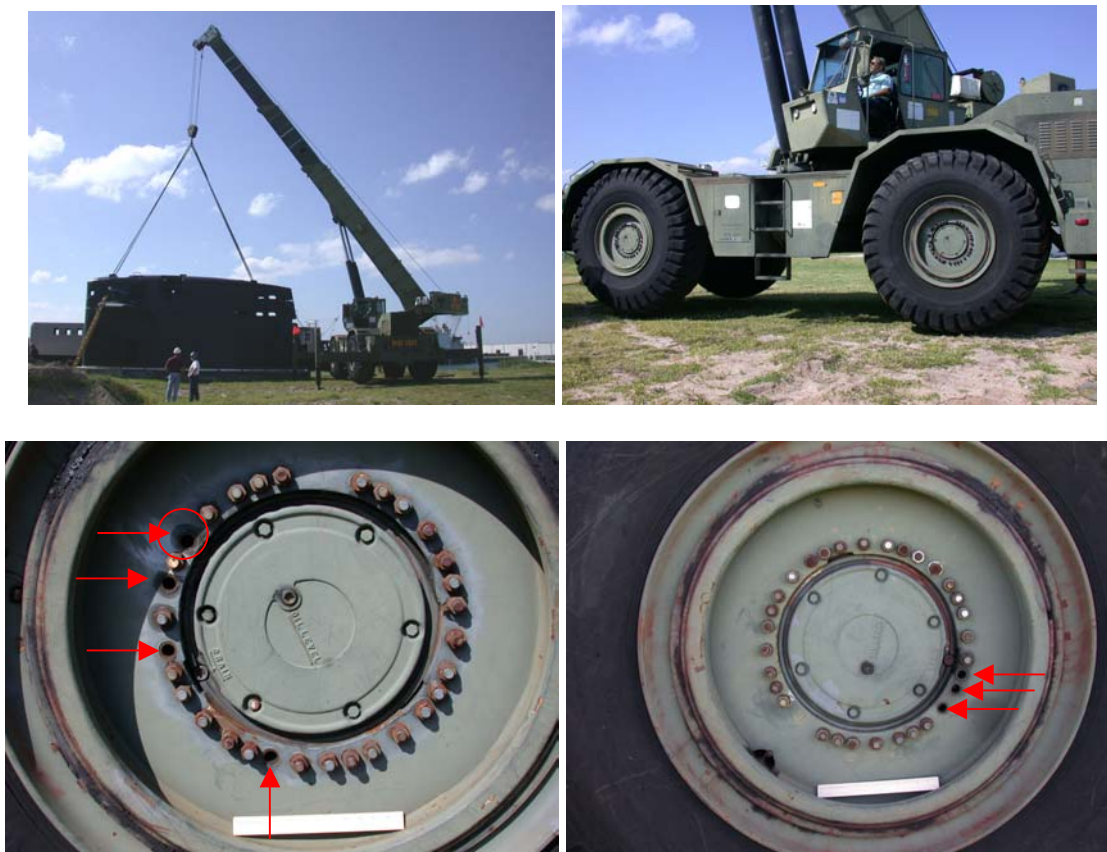
- 2.1 A fractured wheel stud (P/N 9-049-104995) from an RT 990 crash crane (S/N 75190) was submitted for failure analysis after it was found on the ground near the crane. Six additional wheel studs failed in a similar manner, but were not submitted. All of the failed studs were from rear wheels: four from the left rear wheel and three from the right rear wheel. Four additional studs were submitted after they fractured during torquing. A used intact stud of the same design was submitted for comparison purposes.
- 2.2 The studs are reportedly ASTM A490, Type 3 bolts. The studs are intended for one time use and should not be retorqued, per AISC 5-276, *Specification for Structural Joints Using ASTM A325 or A490 Bolts*. The function of the studs is to attach the hubs to the wheels. Figure 1 shows the crane and the rear wheel hubs with the locations of the seven studs that failed in service.

RT 990 crash crane (top), with left and right rear wheel hubs (bottom). Arrows indicate locations of failed studs; circle indicates location of stud submitted for analysis.

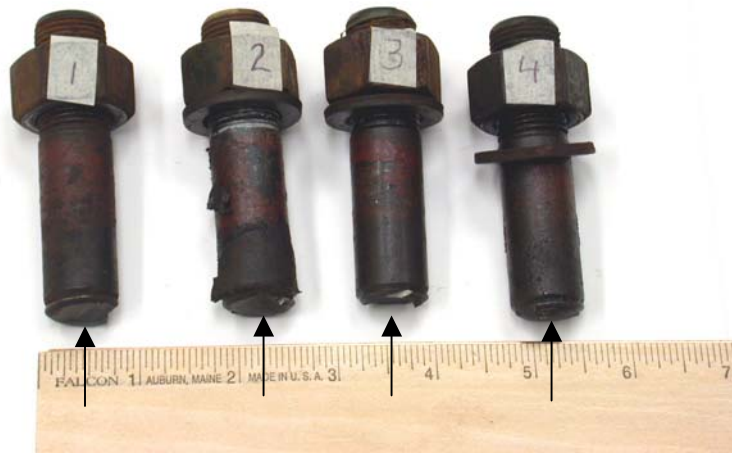
Figure 2

- 3.1 The fractured studs and the intact stud were photographed as-received (Figures 2 and 3). Corrosion products were present in the threads of the intact stud. Three of the fracture surfaces displayed dark/discolored regions, likely pre-existing cracks (Figure 4). Macroscopic fatigue-like features, i.e., crack arrest marks and radial features, were observed on two of the fracture surfaces (Figure 5).
- 3.2 The intact stud was submitted for nondestructive evaluation. Fluorescent magnetic particle analysis revealed no cracks or indications.

Four fractured studs, as-received. Arrows indicate fracture surfaces.

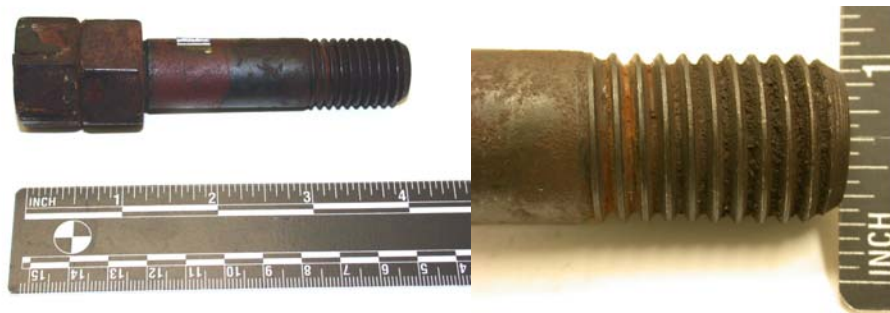
Figure 3

Used intact stud, as-received (left), with a higher magnification view of corrosion products in the threads (right).

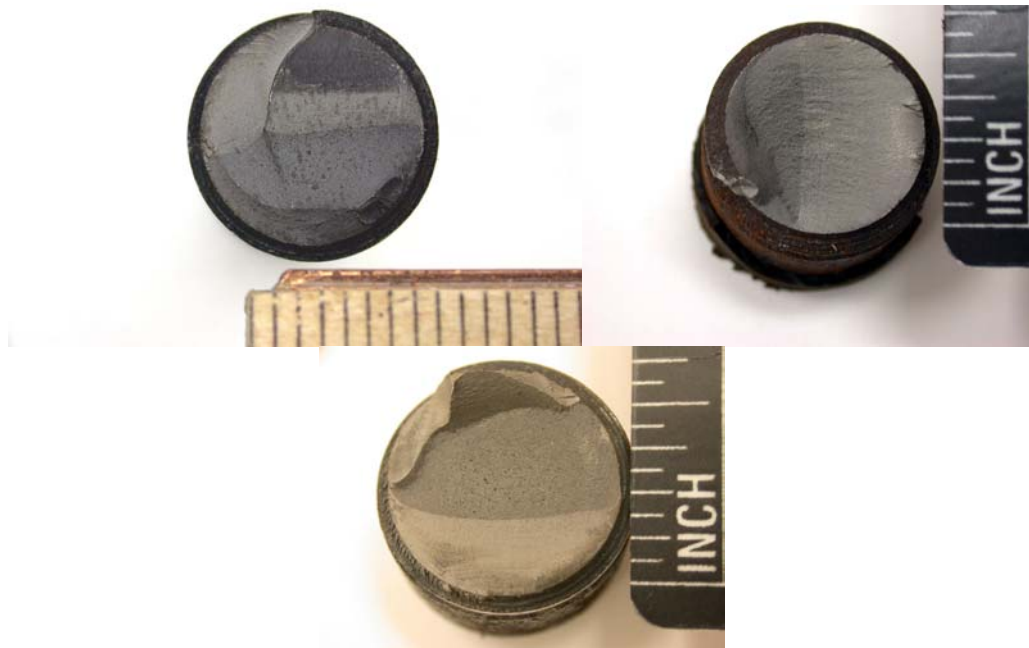
Figure 4

Fracture surfaces of studs 0 (top left), 2 (top right) and 4, showing discolored regions.

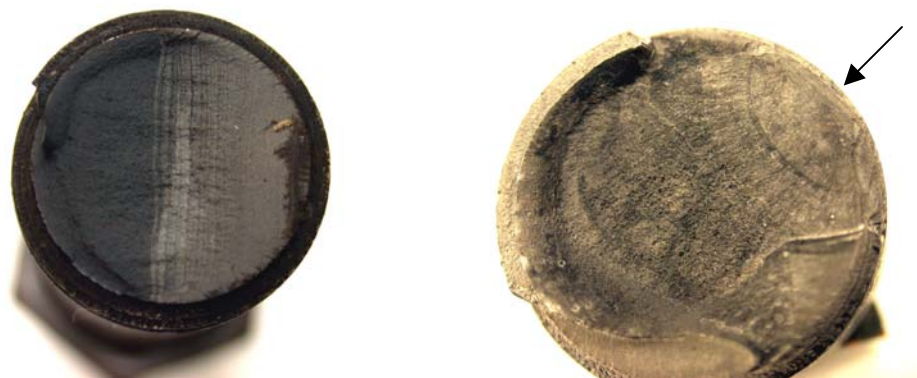
Figure 5

Fracture surfaces showing crack arrest marks (stud 1, left) and radial features (stud 3, right). Arrow indicates origin area. Magnification: 3X

4.1 Macroscopically the cracking appeared fatigue-like, however, no microscopic fatigue features were observed. The absence of microscopic fatigue-like features is common in high strength steels and does not preclude progressive failure. The macroscopic features indicated that the bolts failed under low nominal stress conditions with mild stress concentration.

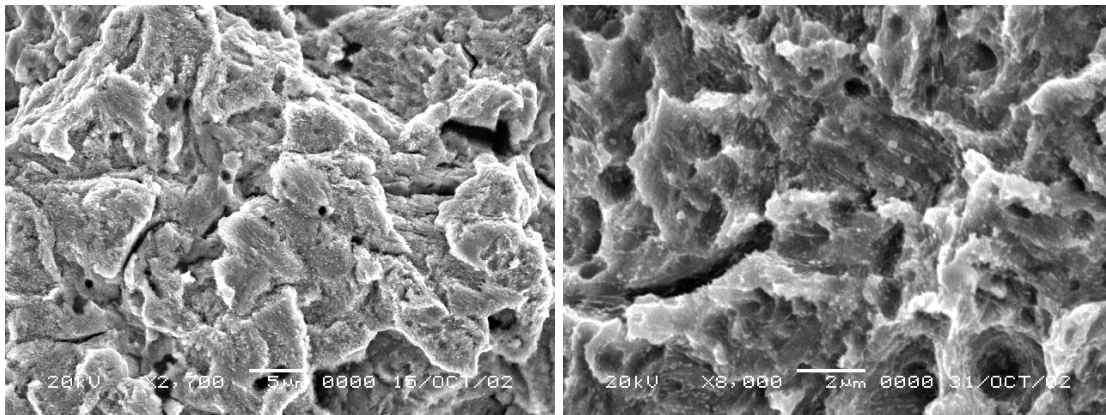
Figure 6

3.3 The failed studs were sectioned and cleaned in preparation for analysis by scanning electron microscope (SEM). All of the fracture surfaces displayed extensive corrosion damage in the discolored regions (Figure 6). The stud 1 and 3 fracture surfaces were heavily corrosion damaged in the regions displaying macroscopic fatigue-like indications. Intergranular features were observed near the edge of the stud 3 fracture surface, opposite the origin area (Figure 7). The final overload regions of all of the studs displayed dimples formed by microvoid coalescence (MVC), indicative of ductile overload (Figure 8). As is common in high strength steels, no microscopic features indicative of fatigue striations were observed.

SEM micrograph showing corrosion damage on stud 0 (left) and stud 1 (right) fracture surfaces. Magnification: left - 2,700X; right - 8,000X

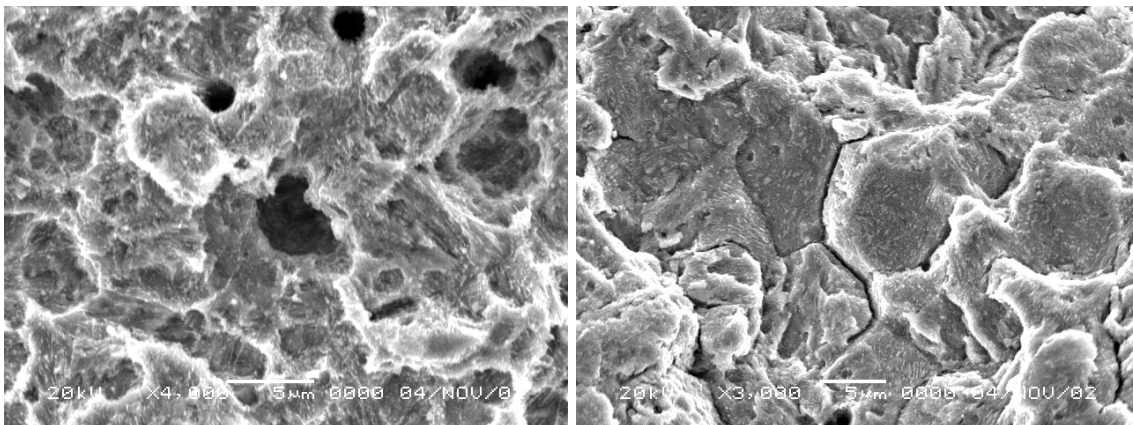
Figure 7

SEM micrograph showing corrosion damage (left) and intergranular features (right) on the stud 3 fracture surface. Magnification: left - 4,000X, right - 3,000X

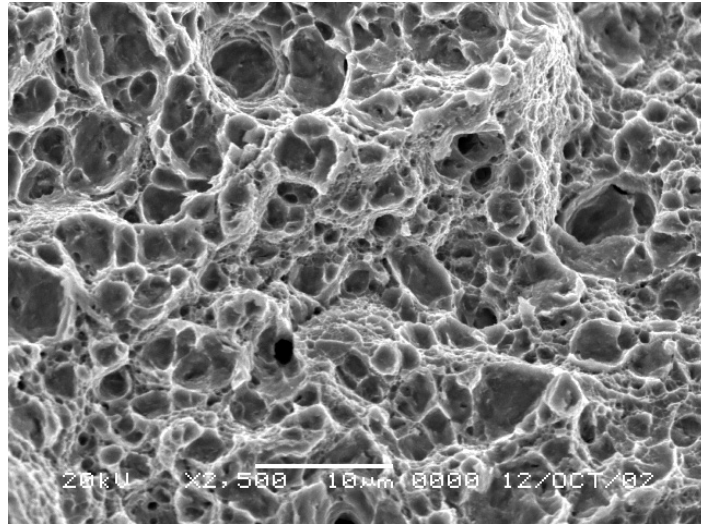
Figure 8

SEM micrographs showing dimples formed by MVC on the stud 0 fracture surface. Magnification: 2,500X.

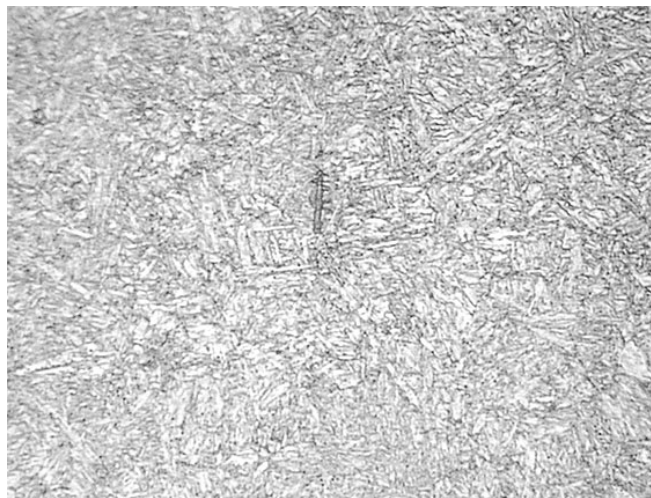
Figure 9

- 3.4 The studs were sectioned longitudinally and prepared for metallographic analysis. The microstructure consisted of bainite and tempered martensite with manganese sulfide stringers (Figure 9). Secondary cracks were observed in the corrosion damaged regions of the fracture surfaces, often associated with stringers open to the surface (Figure 10).

Micrograph of a cross section of stud 2. The microstructure is bainite and tempered martensite with manganese sulfide stringers. Etchant: 2% nital. Magnification: 1,000X

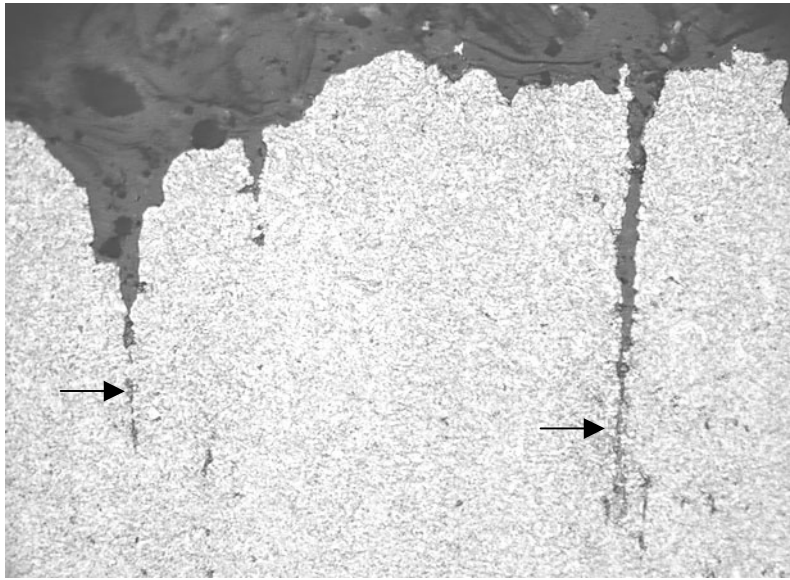
Figure 10

Micrograph of a cross section of stud 3 showing secondary cracks associated with stringers (arrows). Etchant: 2% nital. Magnification: 500X

4.2 The wheel studs likely failed due to fatigue exacerbated by corrosion. Cracks originated in the roots of the last threads and extended through approximately half of the cross sectional area of the studs, rendering them unable to withstand the service or nominal torque loads. The studs are intended for one time use and should not be retorqued, per AISC 5-276, *Specification for Structural Joints Using ASTM A325 or A490 Bolts*.
